# **TOWNSHIP OF WILMOT**

## **Council Meeting Agenda**

**Holland Mills Road Bridge – Structure No. 17B/B-T13**

**Schedule “B” Class Environmental Assessment**

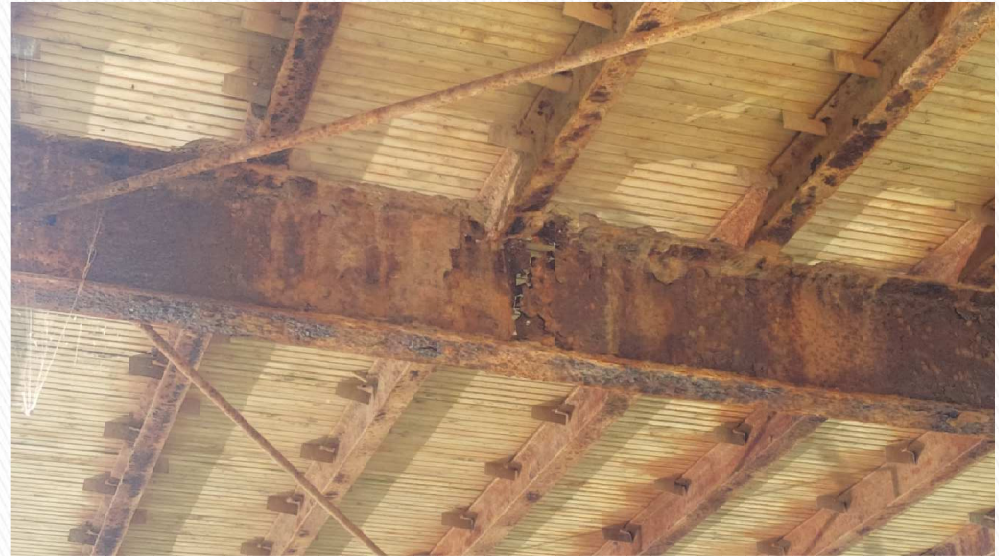
**Severely Deteriorated Floor Beam**

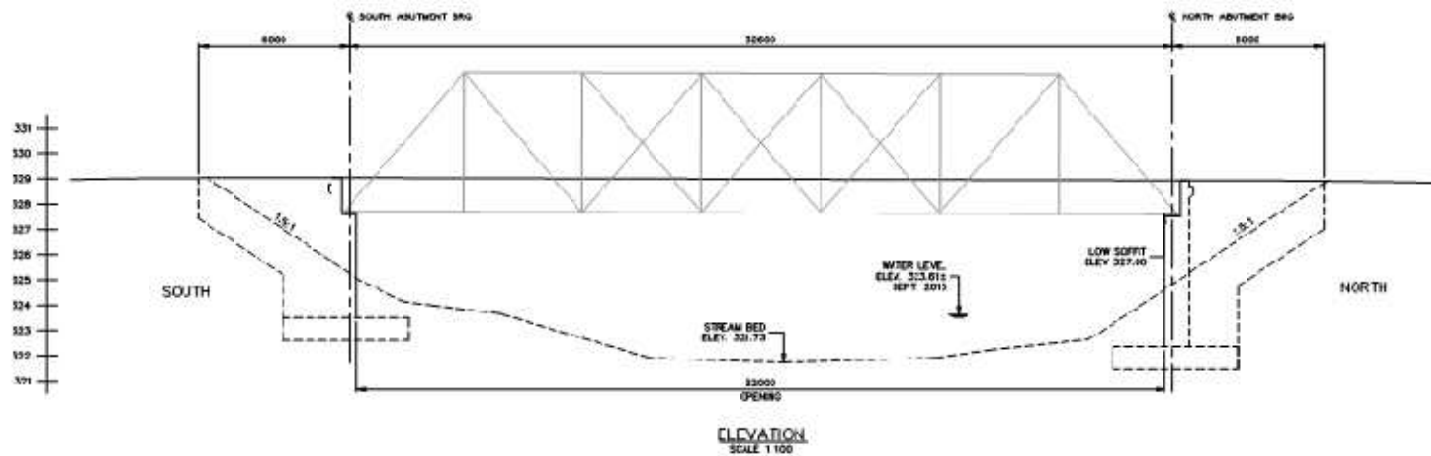
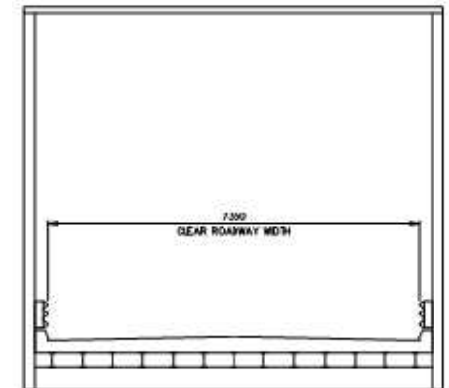
DECK CROSS SECTION  
SCALE 1:50

THIS REPLACEMENT ALTERNATIVE HAS AN ESTIMATED CONSTRUCTION COST OF \$1,770,000

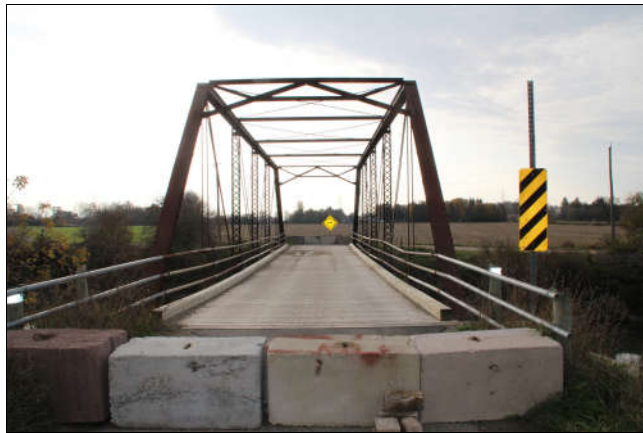
The wood curbed, wood bridge deck is 29.7 metres long and 5.1 metres wide. The bridge is deficient in width and capacity and is closed and barricaded on both approaches (Figures 20 & 21).

Figure 20 barricaded south approach

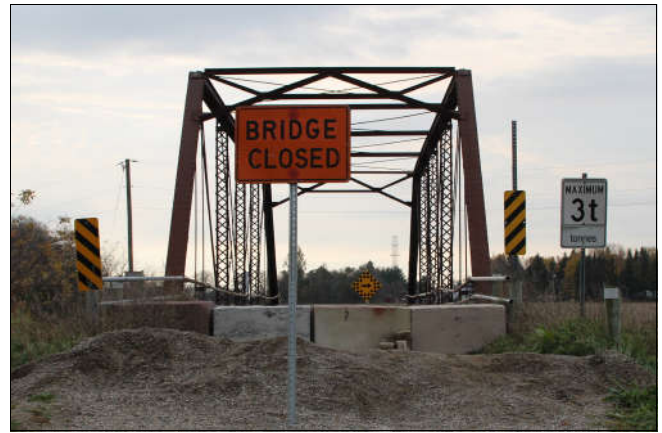
Figure 21 barricaded north approach

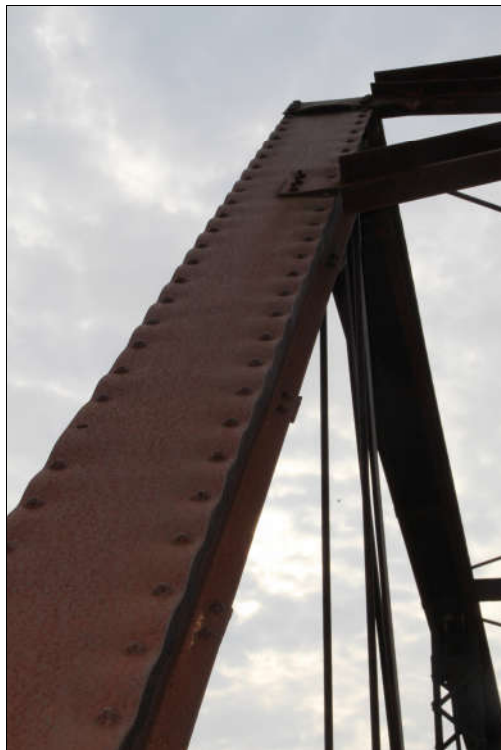
All of the steel is rusty, with no evidence of paint (Figures 22 - 38). End posts and top chords are built-up steel consisting of a “wave” panel, rivet-connected to an I-beam (Figures 22 & 23).

Figure 22 end post

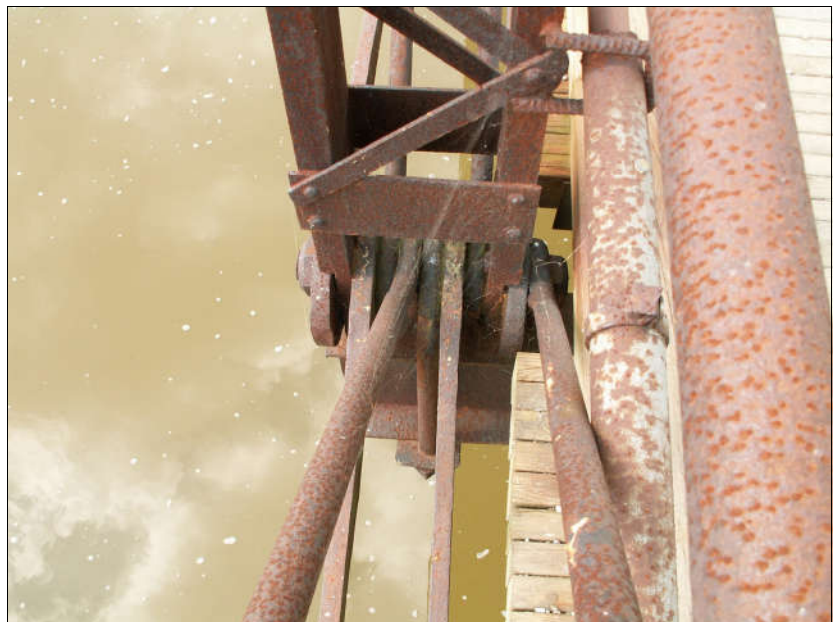
Figure 28 bottom chord connection - [historicbridges.org](http://historicbridges.org)

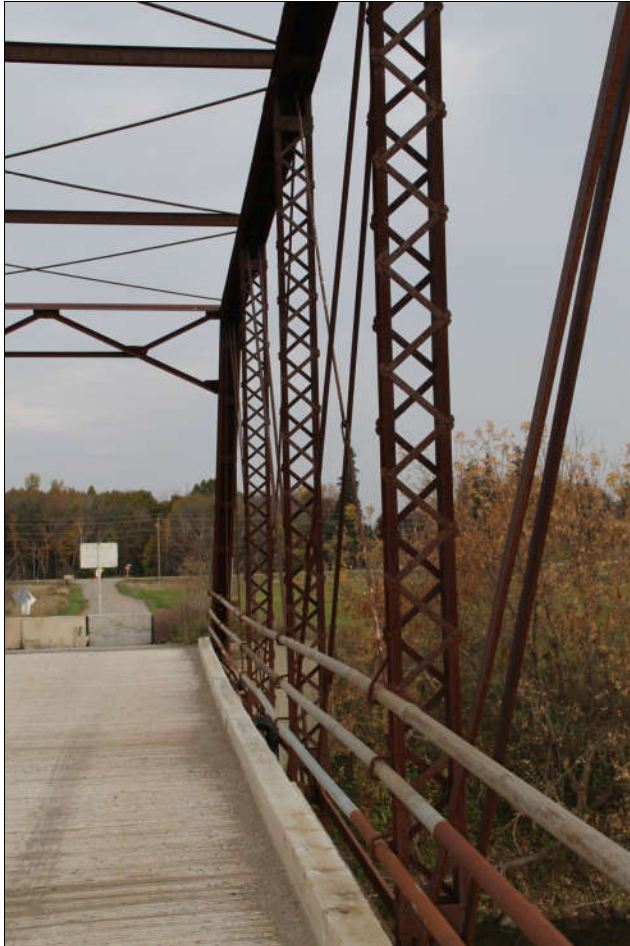
Diagonal members and sway bracing are steel rods with turnbuckles (Figure 29), including one unusual turnbuckle (Figure 30) and more typical turnbuckles (Figure 31). Loop-welded eye bars with teardrop-shaped holes are evident (Figure 27).

Figure 29 steel rod diagonal members & sway bracing

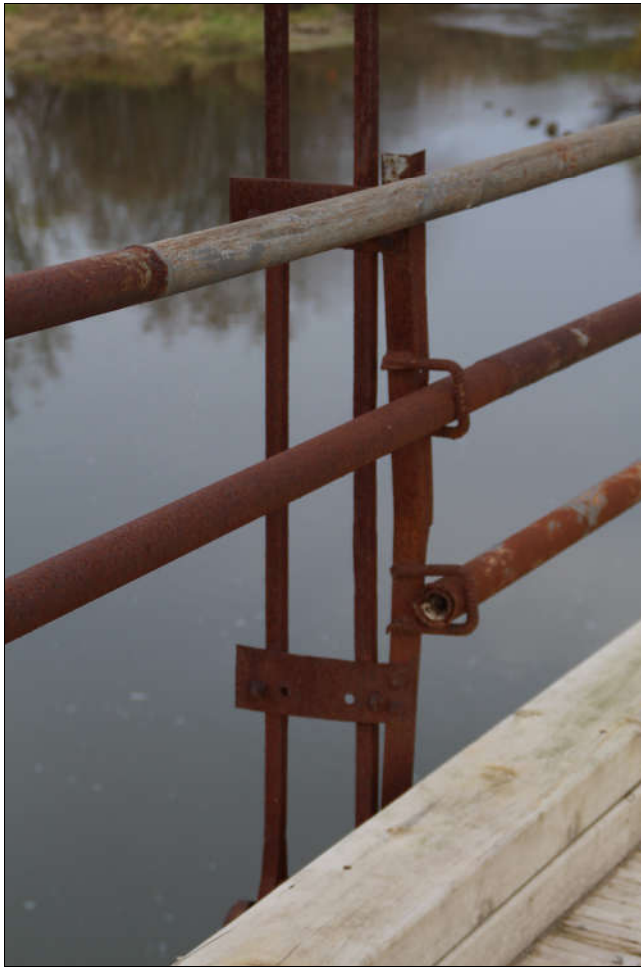
Figure 33 pipe railing with missing section

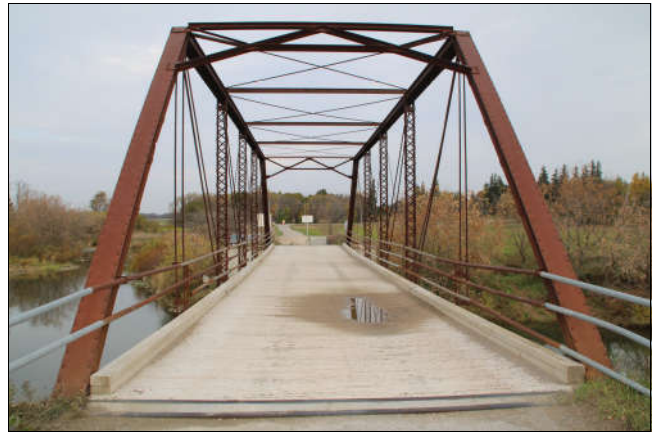
Figure 34 bridge deck - note ponding near southeast end

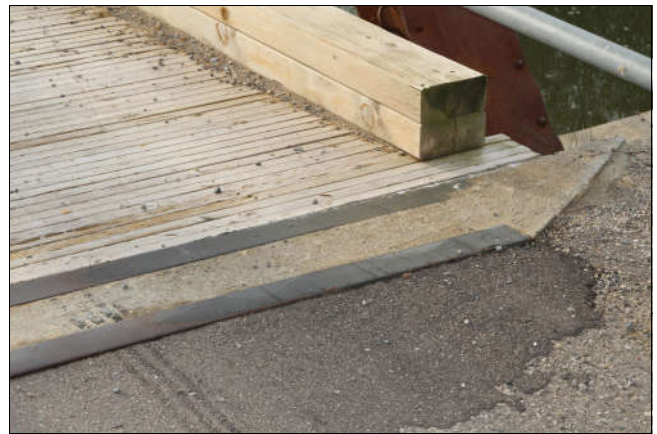
Figure 35 bridge deck, curb & expansion joint

The deck has a wood curb (Figure 35). Deck beams and stringers are severely rusted with much loss of material (Figure 37). Concrete abutments (Figure 38) were refaced in 2007.<sup>9</sup>

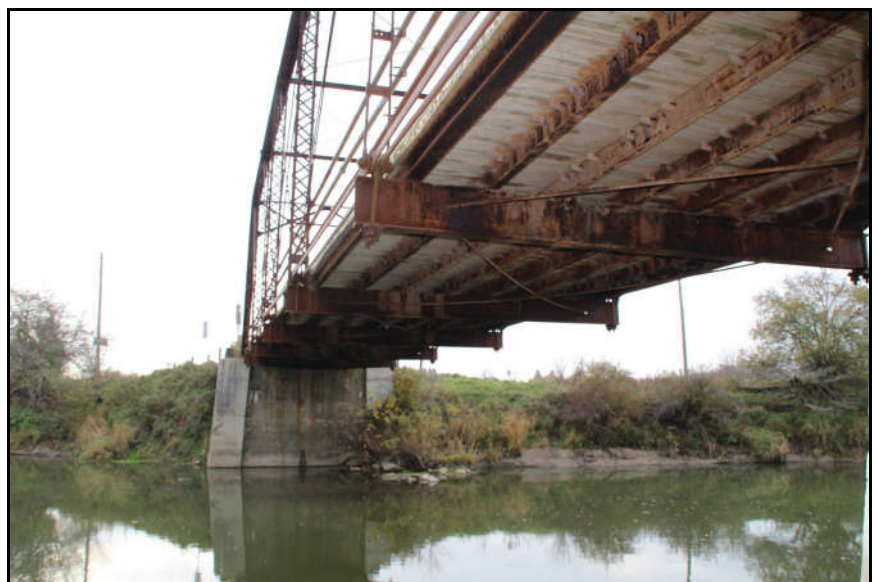
Figure 36 bridge deck, beams and abutments viewed from the north

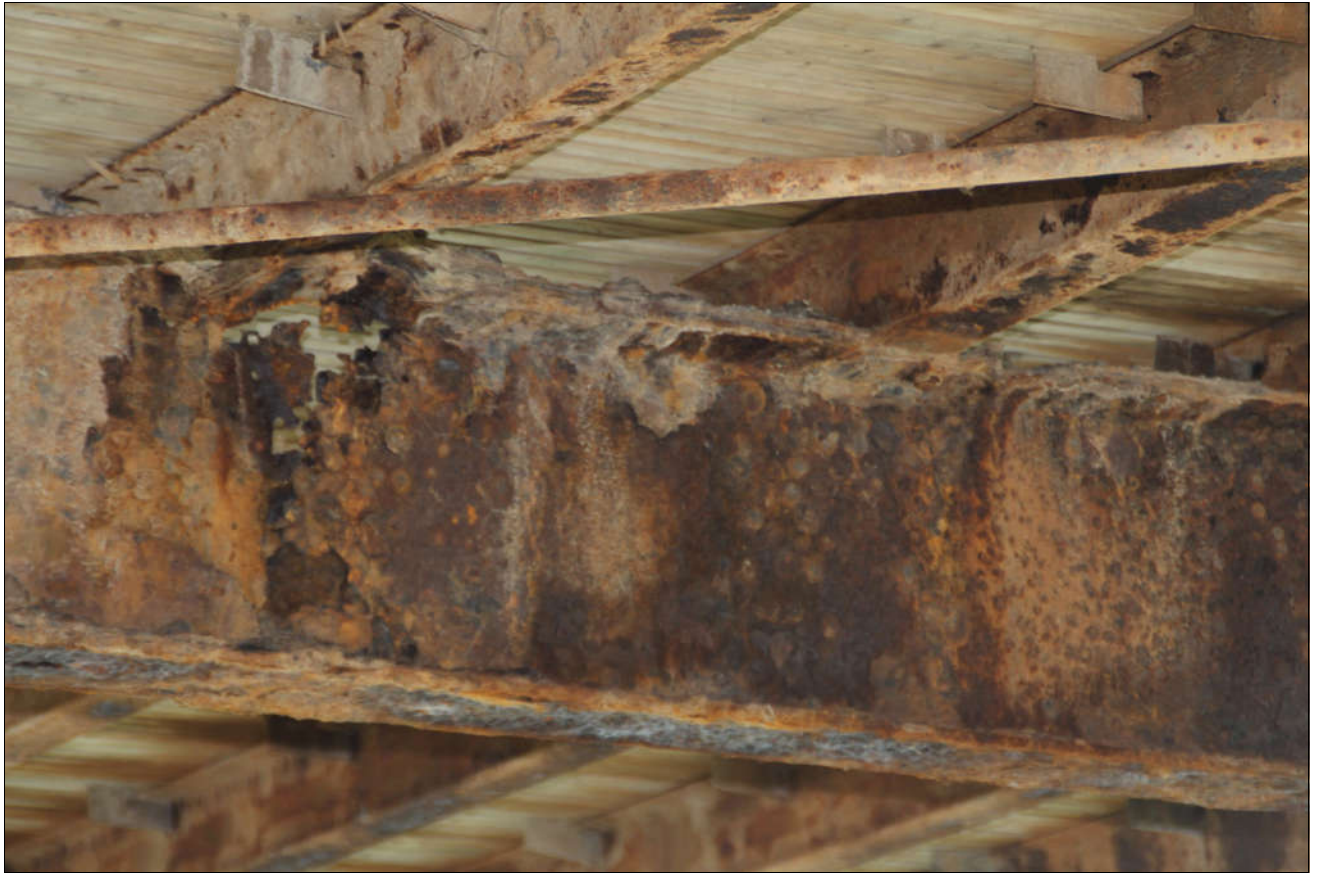
Figure 37

severely rusted deck beam and stringers

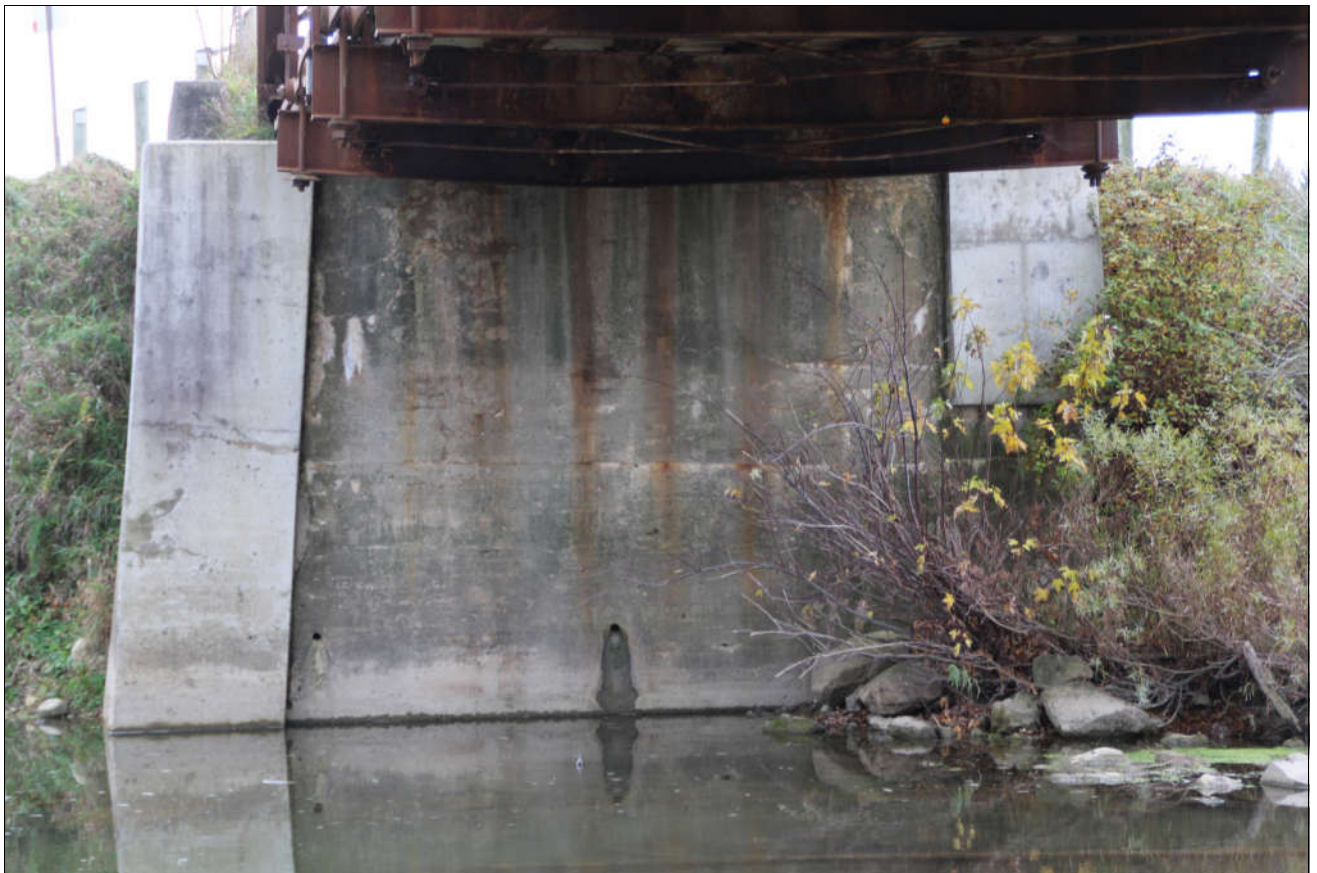
Figure 38

southerly concrete abutment - refaced 2007

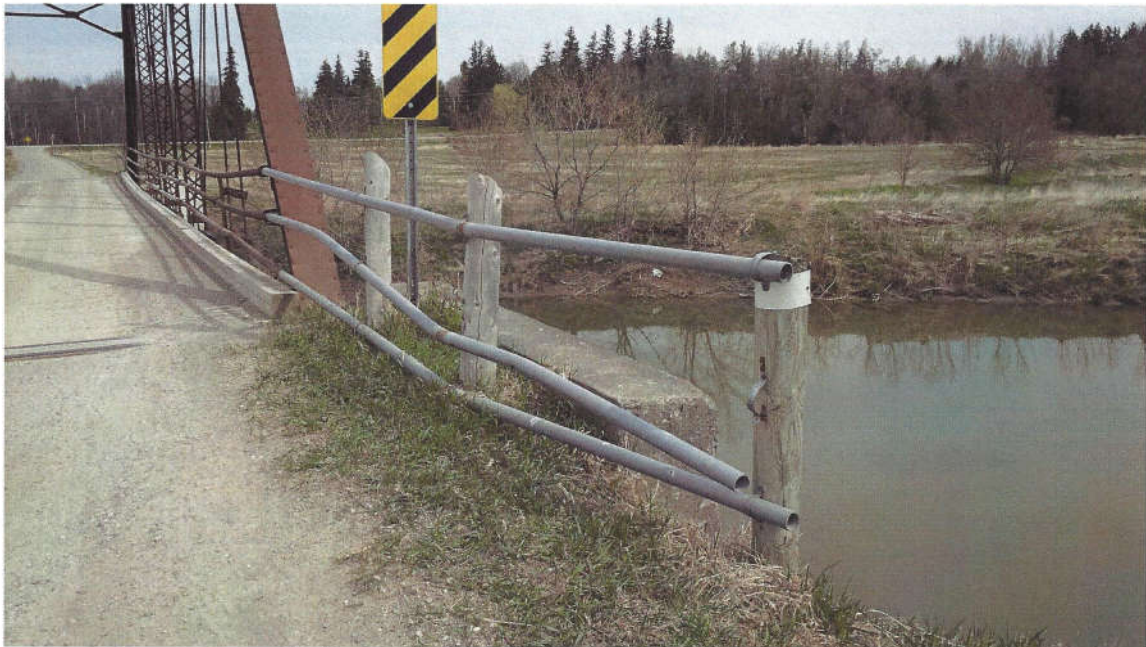
**7. Approach Barrier at Southeast - Impact Damage**

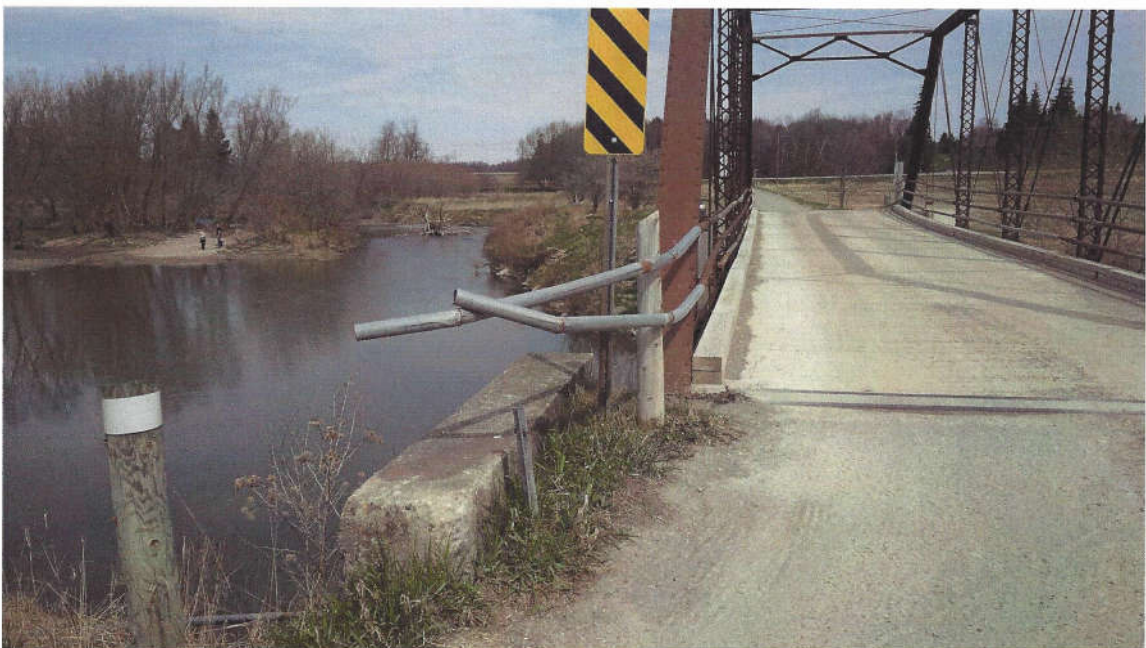
**8. Approach Barrier at Southwest - Impact Damage**

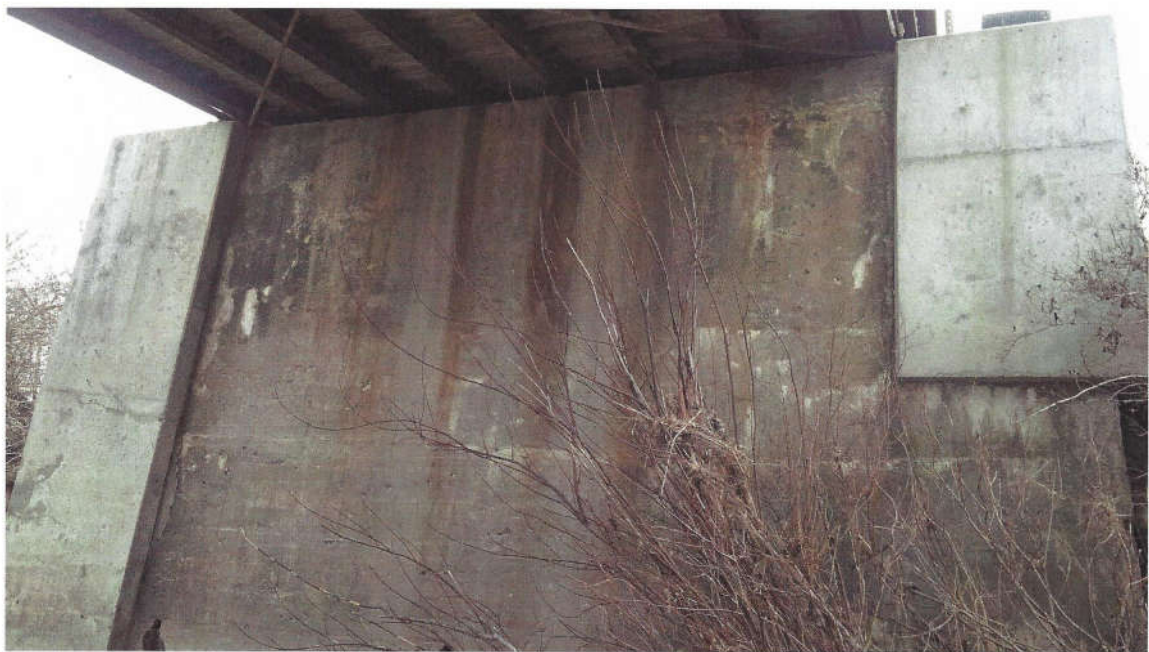
12. South Abutment - Cracking with Efflorescence

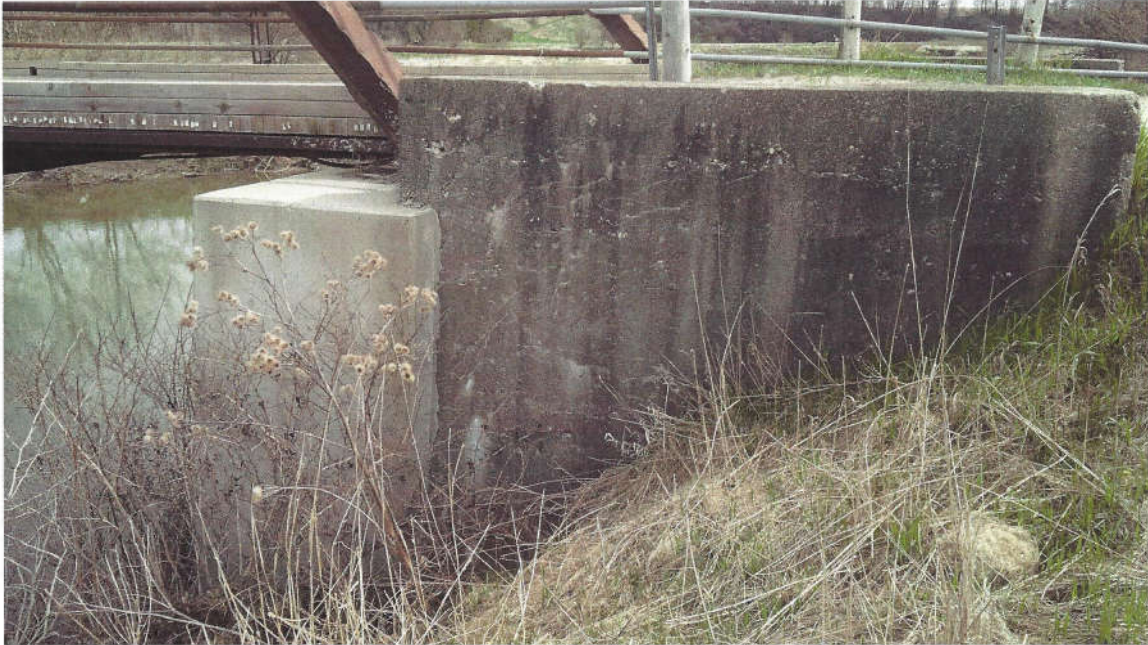
13. Southwest Wingwall - Cracking with Efflorescence

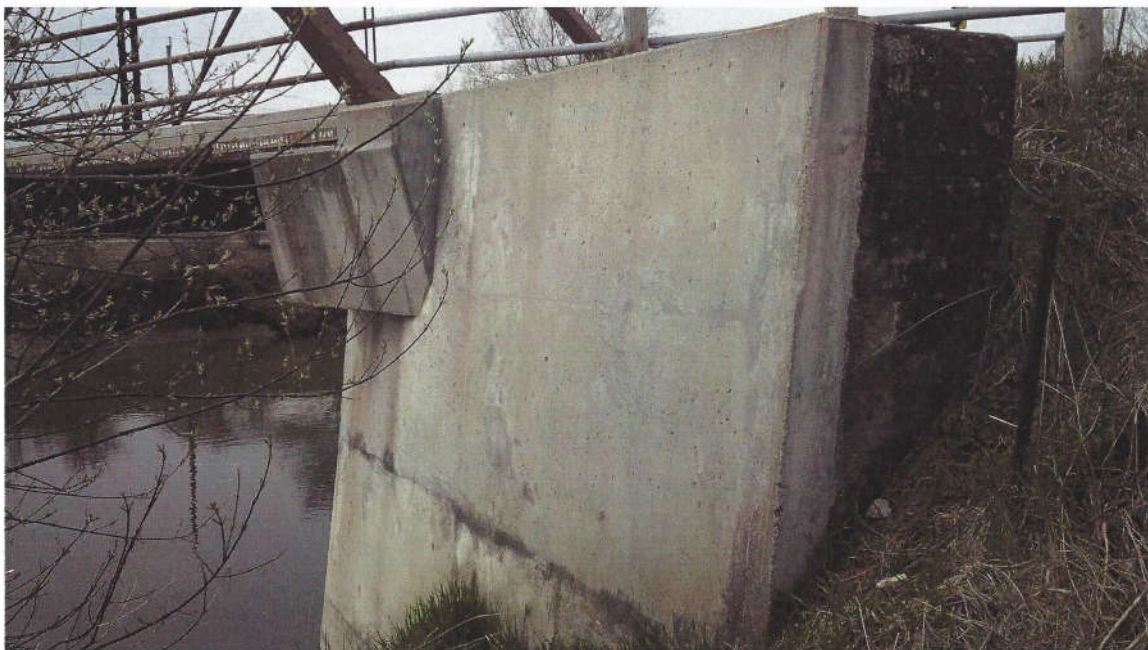
14. Northeast Wingwall

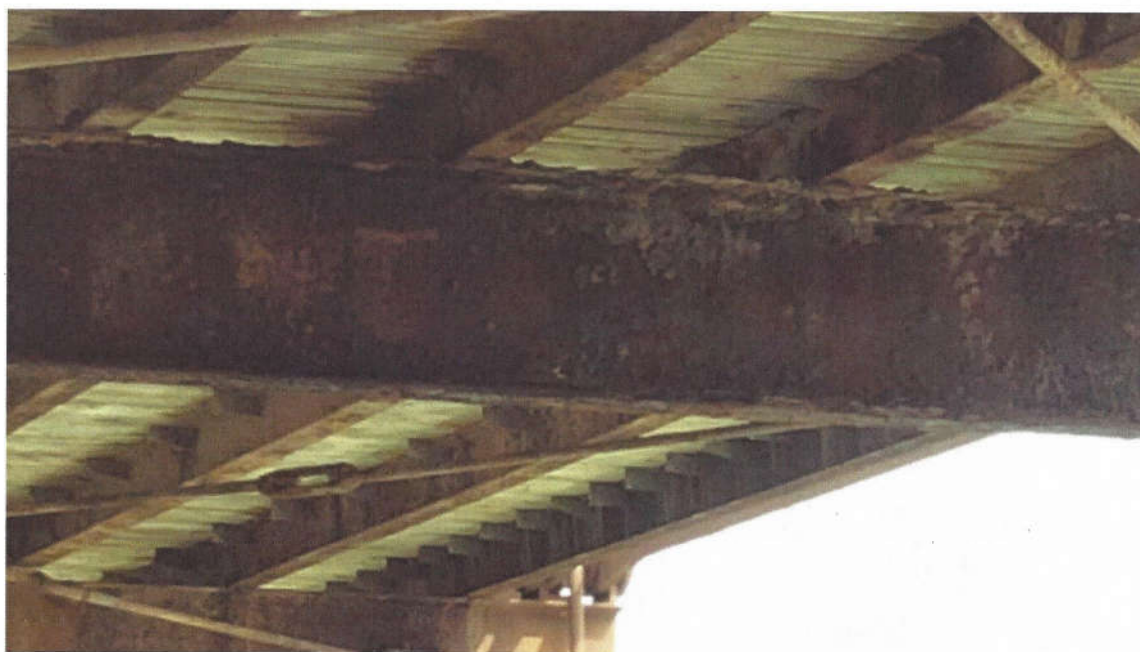
16. Second Beam from South - Severe Corrosion with Perforations

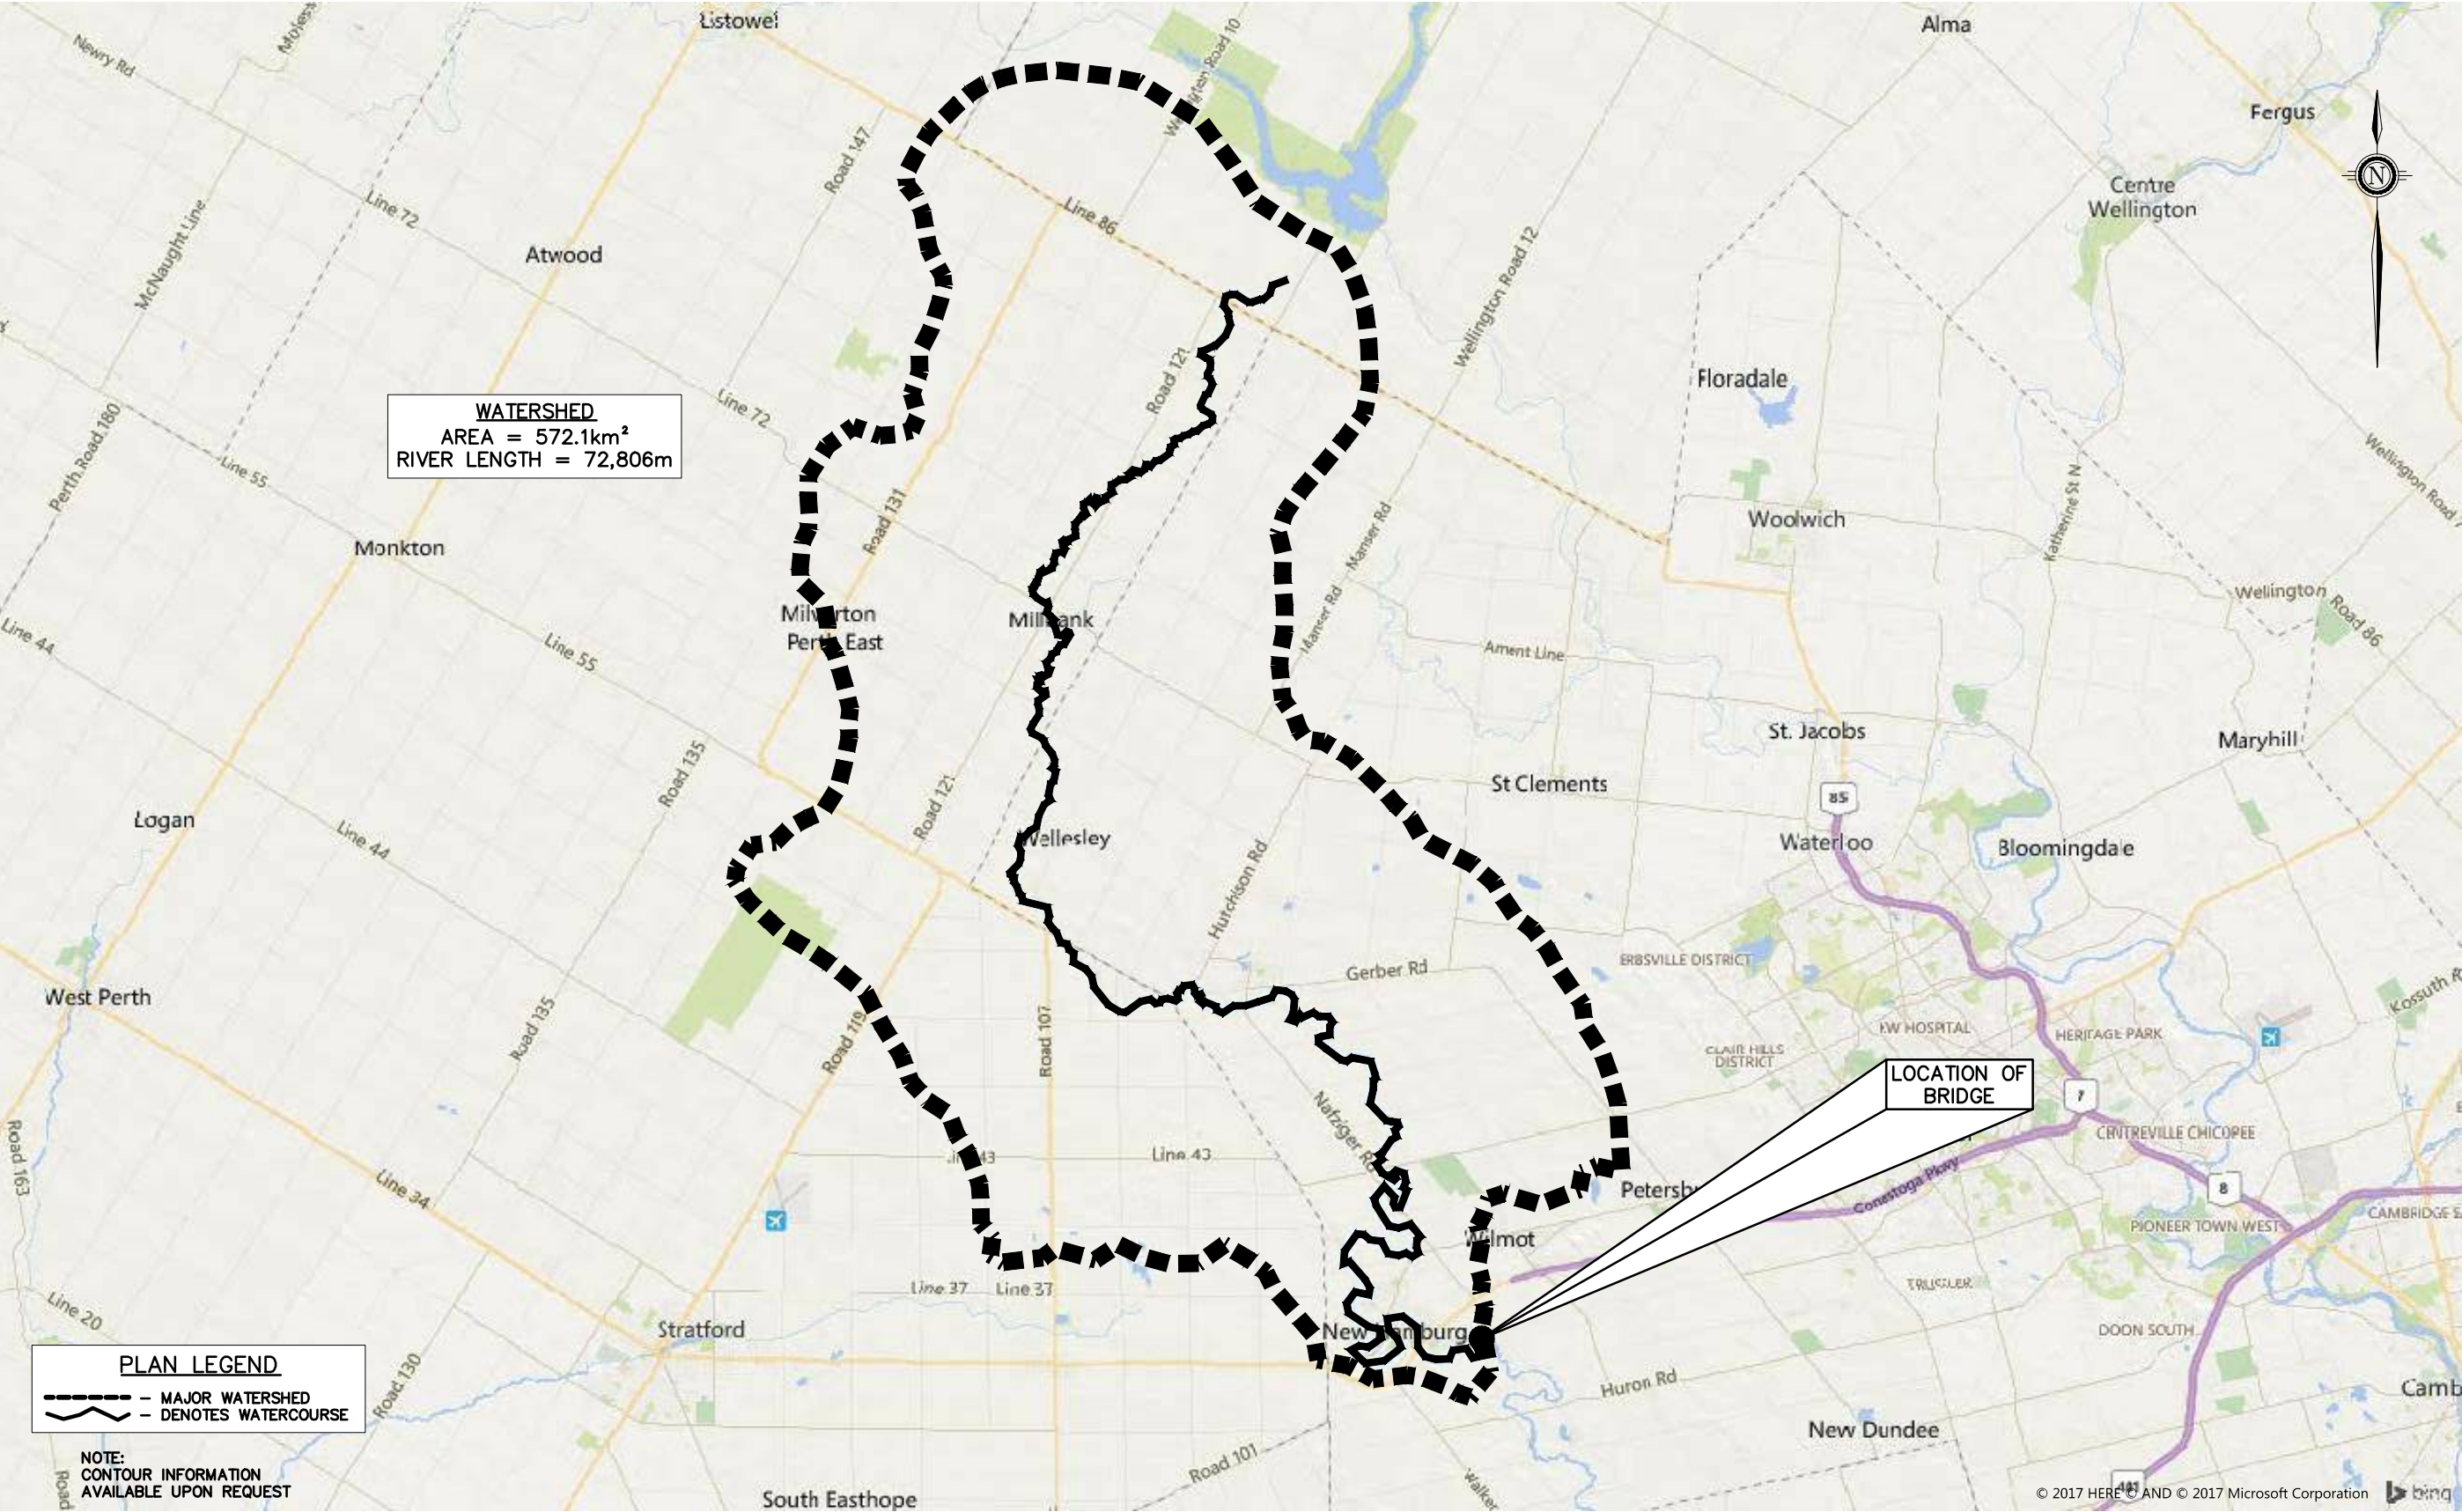
**WATERSHED**  
AREA = 572.1km<sup>2</sup>  
RIVER LENGTH = 72,806m

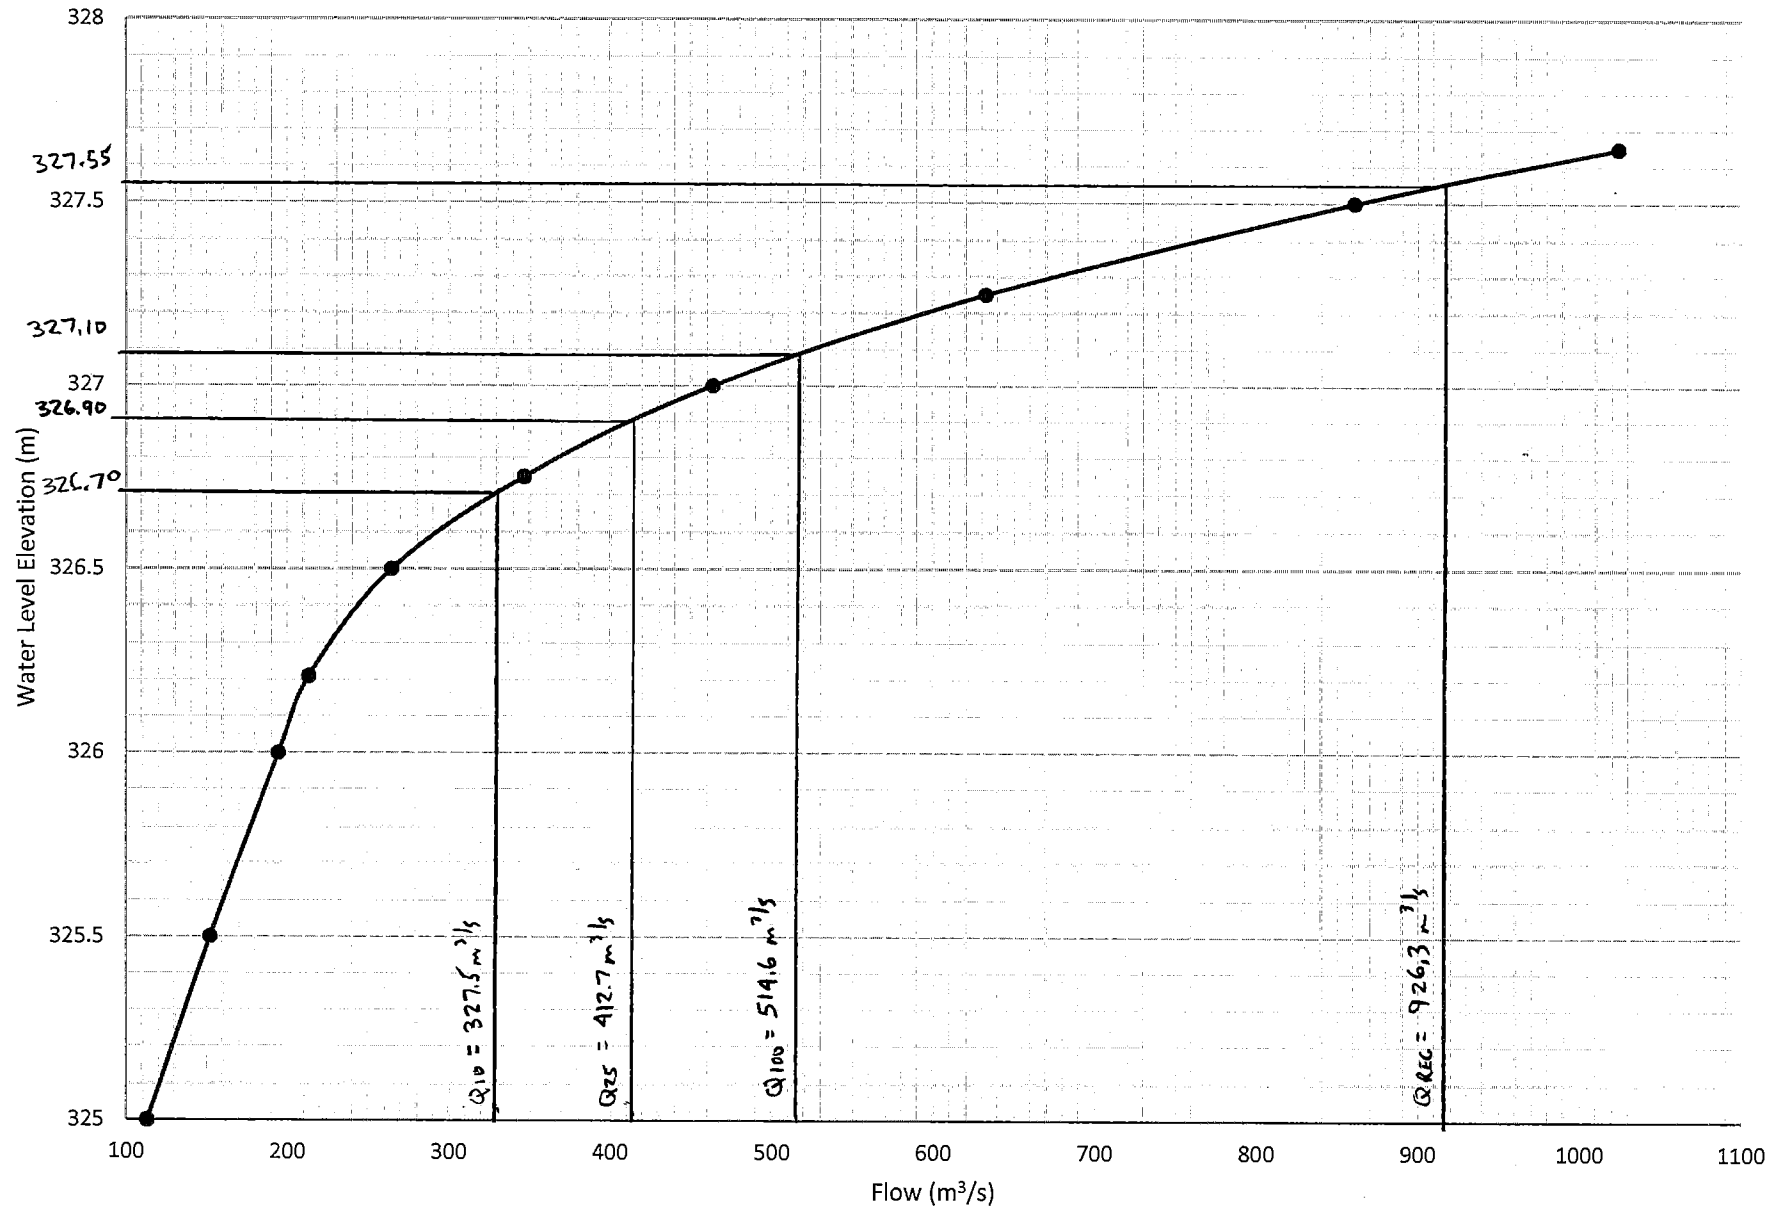
Water Level Elevation vs. Flow for Existing Conditions

Existing Conditions		
Design Storm	Flow m³/s	Existing High Water Elevation (m)
10 Year	327.5	326.70
25 Year	412.7	326.90
100 Year	514.6	327.10
Regional	926.3	327.55

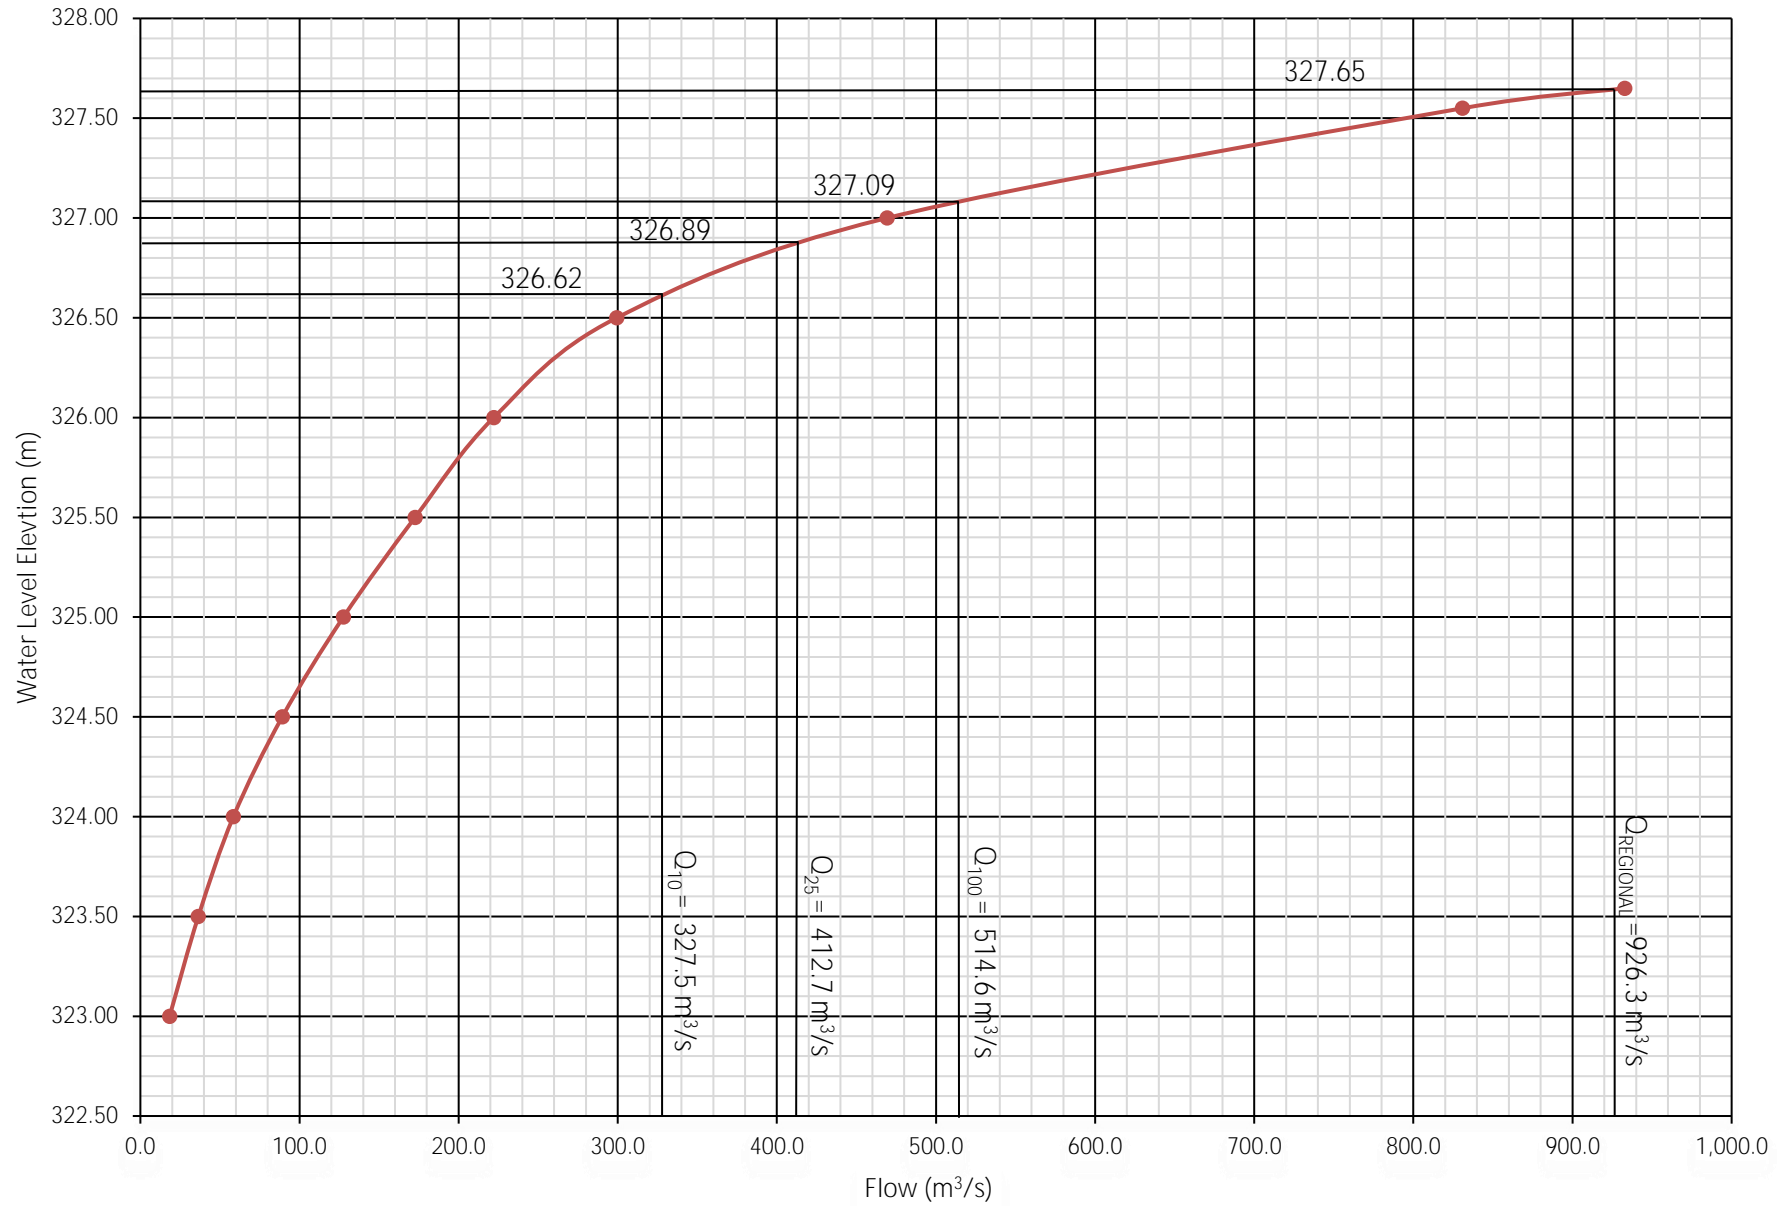
Water Level Elevation vs Flow for Proposed Structure

PROPOSED CONDITIONS		
Design Storm	Flow m³/s	Proposed High Water Elevation (m)
10 Year	327.5	326.62
25 Year	412.7	326.89
100 Year	514.6	327.09
Regional	926.3	327.65
